RUSSIAN FEDERATION
MINISTRY OF TRANSPORT OF THE RUSSIAN FEDERATION
FEDERAL AIR TRANSPORT AGENCY
AIRWORTHINESS DIRECTIVE

No. 2023-AHCAT, AHCAT-CK-03

Applicability – ANSAT helicopters (ANSAT, ANSAT-GC models) and their modifications

TECHNICAL DECISION No. 1/144-2023-KB3
on continued airworthiness of the ANSAT helicopters (ANSAT, ANSAT-GC models)

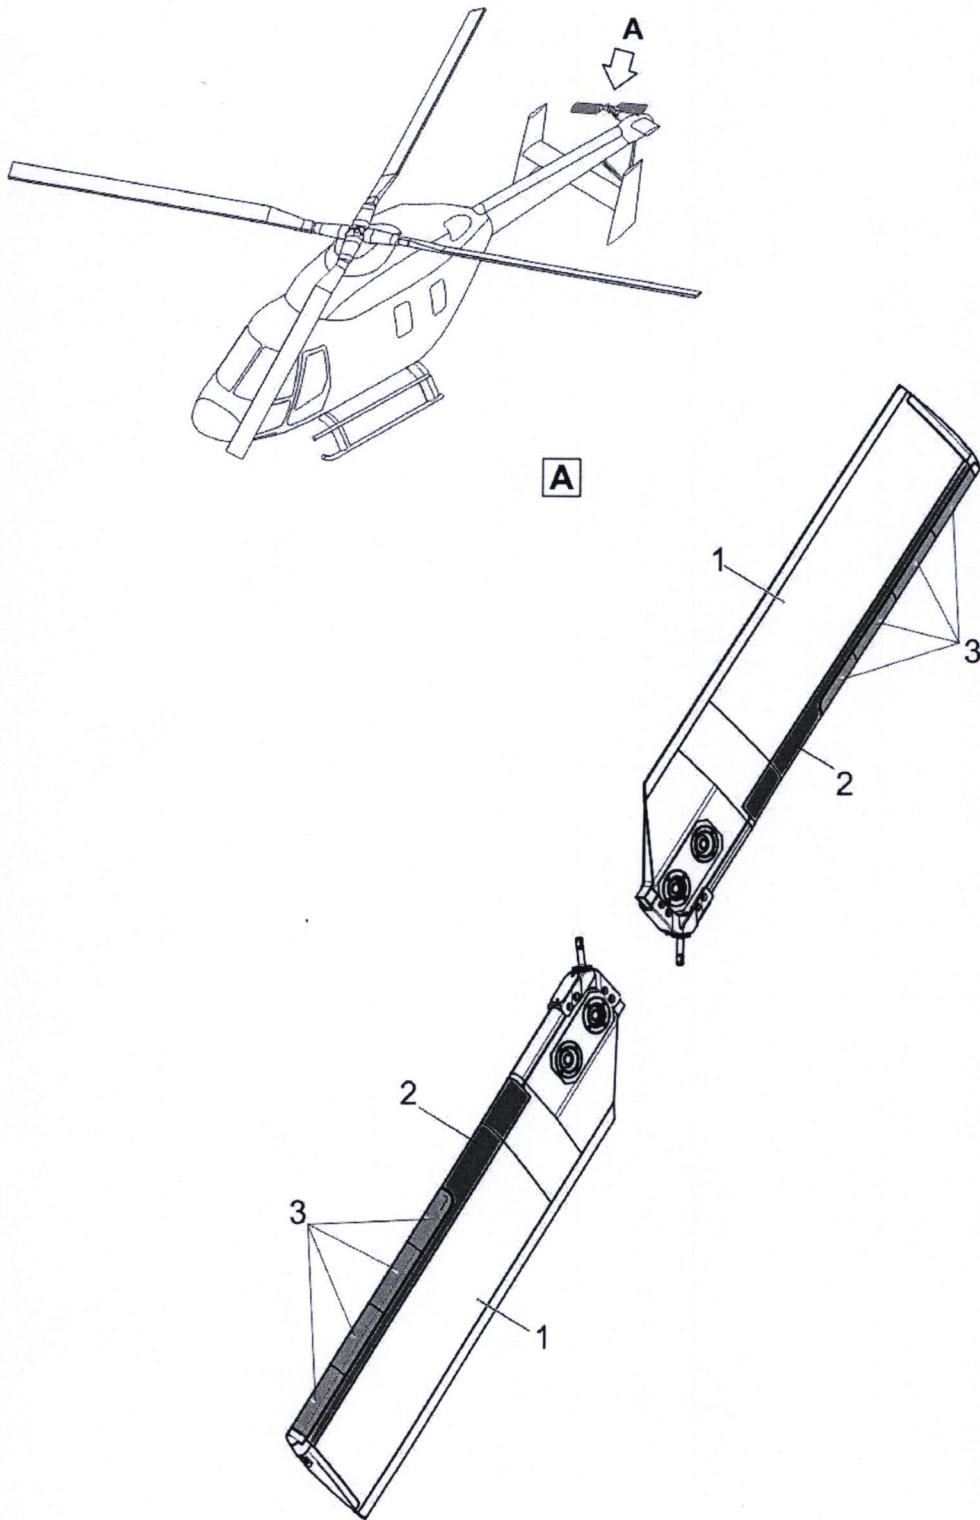
Fig. 1 TR blade

During the inspections of the tail rotors 333.3510.0000 of the ANSAT helicopters being in operation and in the production cycle, a manufacturing defect of blades 333.3950.1000 was revealed – non-glueing of the blade edge tippings 333.3950.1203-03(05) together with the rubber layer of the strip 333.3950.1200 due to the low adhesion of the rubber layer to the fiberglass layers.

1. When carrying out periodic technical maintenance within the scope of "50 flight hours // 12 calendar months" maintenance form, additionally check for the absence of non-glueing of the strips 333.3950.1200 and blade edge tippings 333.3950.1203-03(05) (pos. 2 and 3, Fig. 1, Appendix 1) of the tail rotor blades 333.3950.1000 according to the temporary task card 064.10.00k (Appendix 2), at that, in case of detection of non-glueing, the tail rotor should be removed from operation and sent to JSC "Kazan Helicopters" to eliminate the defect.

2. In case of detection of non-glueing, the tail rotor should be removed from operation and sent to JSC "Kazan Helicopters" for repair.

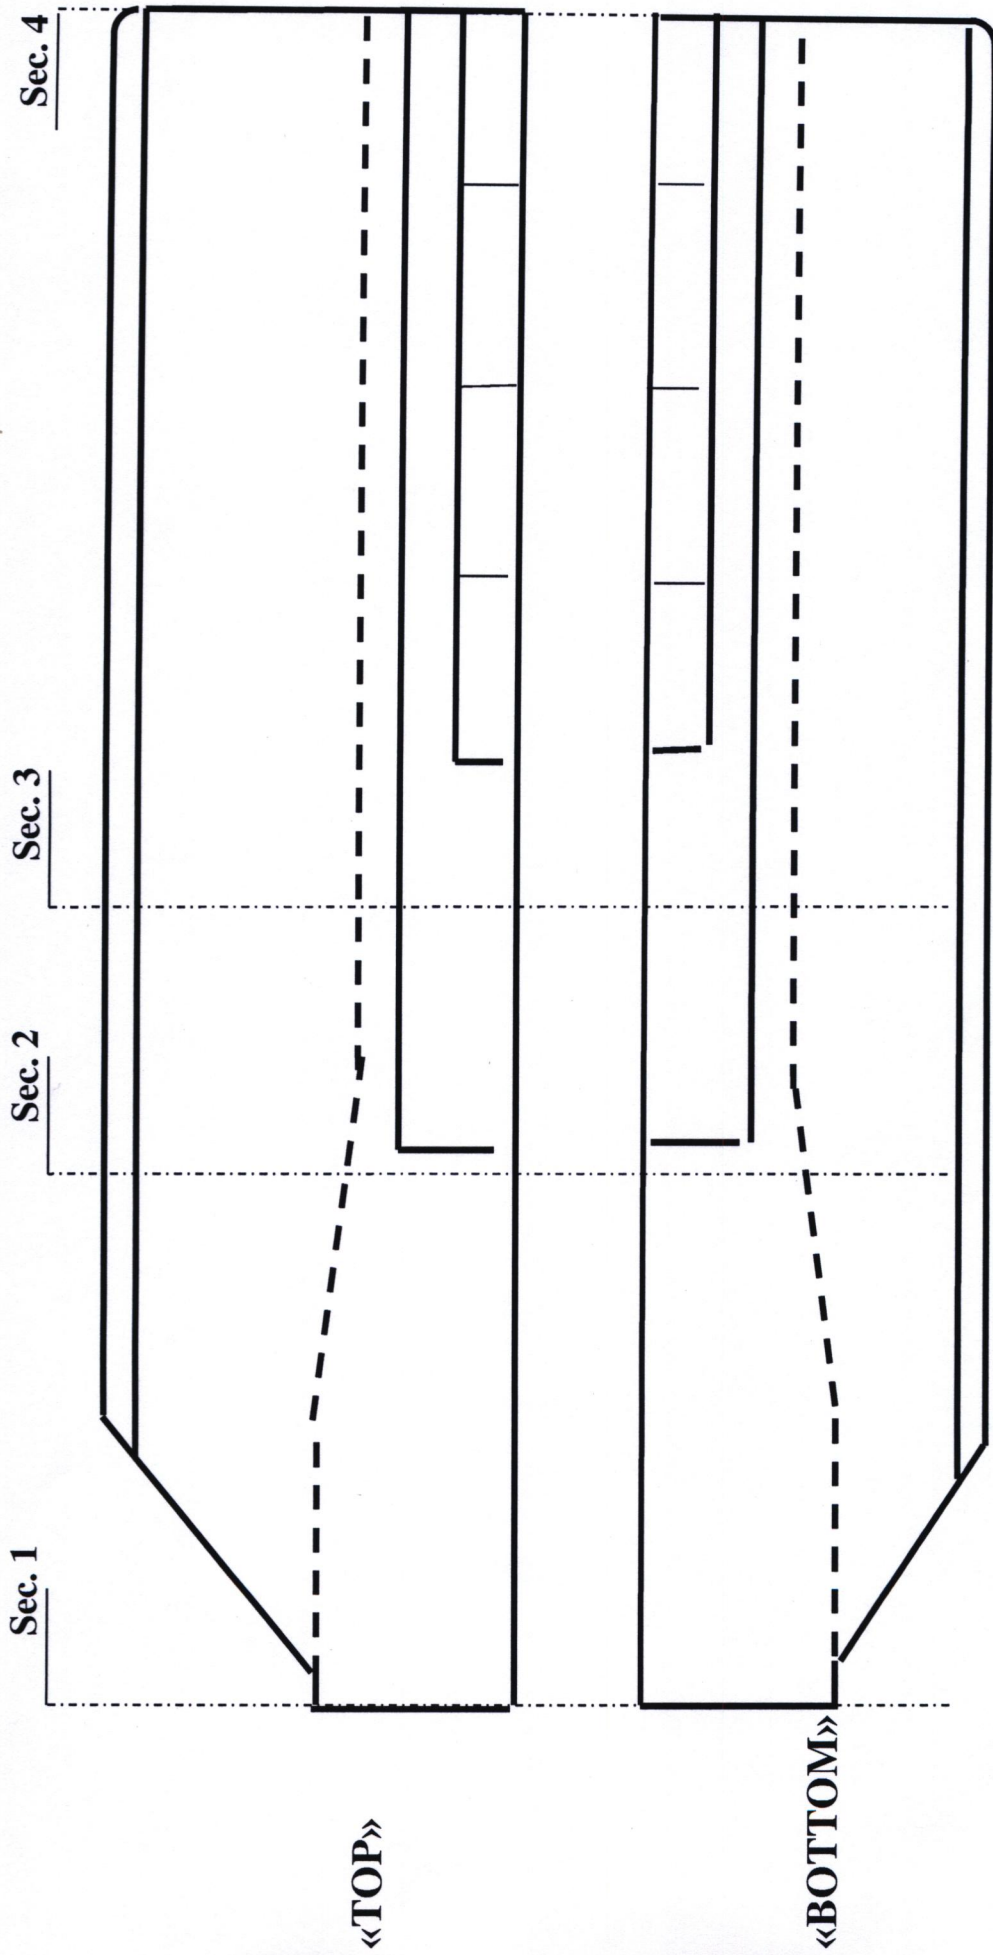
Figure 201 – The template of the chart of non-glueing and dents on the tail rotor blade (to be completed when non-glueing and dents are detected).

Temporary task card 064.10.00к	
Procedure: Control of condition of the strips and tail rotor blade edge tippings rubber layer and control of the absence of non-glueing	Corrective actions
Operations and technical requirements	
<ol style="list-style-type: none"> 1 Work is allowed to be carried out without removing the tail rotor blades from the helicopter. 2 Clean the tail rotor blades according to TC No. 064.10.00c. <p align="center">ATTENTION. WIPE THE TAIL ROTOR BLADES DRY BEFORE PERFORMING THE FOLLOWING OPERATIONS.</p> <ol style="list-style-type: none"> 3 Check the absence of non-glueing of rubber layer of the strips and tail rotor blade edge tippings by tapping with a duralumin hammer, proceeding as follows: <ul style="list-style-type: none"> - tap the entire rubber area of the strips and blade edge tippings with a free fall of the duralumin hammer from a height of no more than 10 ... 15 mm or with soft blows from a distance of no more than 10 mm, avoiding traces of tapping. Violation of glueing is characterized by a change in tone; - if any defects are detected, fill in the chart of non-glueing and dents (see Figure 201), make marks on the tail rotor blades with a soft pencil. <p>The presence of non-glueing is not allowed.</p> 4 Perform a visual check of the condition of the rubber layer of the tail rotor blade strips for the absence of damage. Crumbling of the rubber layer with a total area of no more than 10 cm² with the size of a single crumbling with an area of no more than 2.5 cm² and a width of no more than 0.5 cm is allowed.
