TECHNICAL DECISION RRJ0000-OR-470-4950/A

on continued airworthiness of aeroplane RRJ-95
with deactivated EPAS system of entrance/service doors in automatic mode

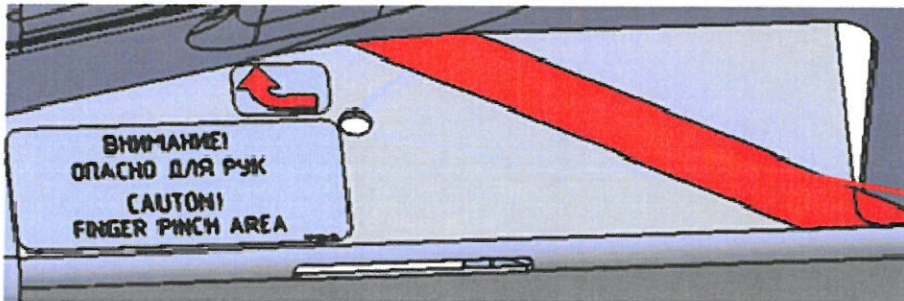
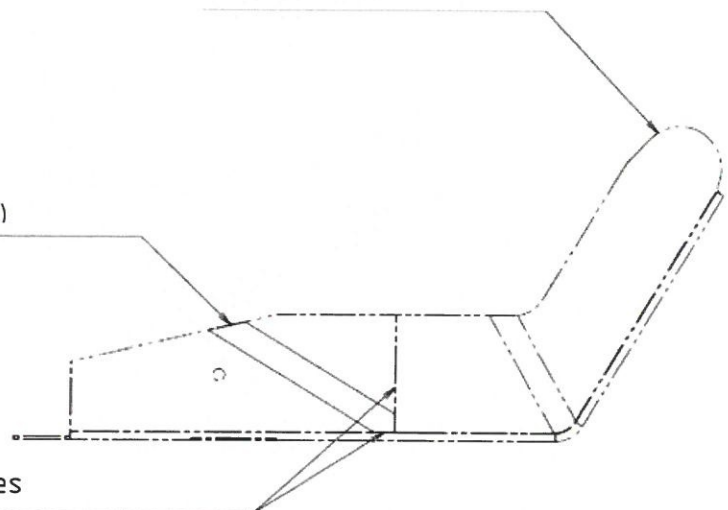
Fig. 3 (Aft passenger and service door)

Align the placard with cover edges

- To install new and shift earlier installed placards: on front passenger door (see Fig.1, Fig.4, Fig.5), on front service door (see Fig.2, Fig.4, Fig.5), on aft passenger and service doors (see Fig.3, Fig.4, Fig.5) in accordance with AMM task 11-00-00-900-801 «Installation and removal of inscriptions».

4. After SB implementation RRJ-52-00485-БД to remove placards p/n T7.7513.199.001, T7.7513.199.002 (see Fig. 4) installed in accordance with Technical Decision RRJ0000-OR-470-4950/A: on front passenger doors (see Fig. 1, Fig. 4), front service door (see Fig. 2, Fig. 4), on rear passenger and service doors (see Fig. 3, Fig. 4) in accordance with AMM task 11-00-00-900-801 «Installation and removal of inscription».

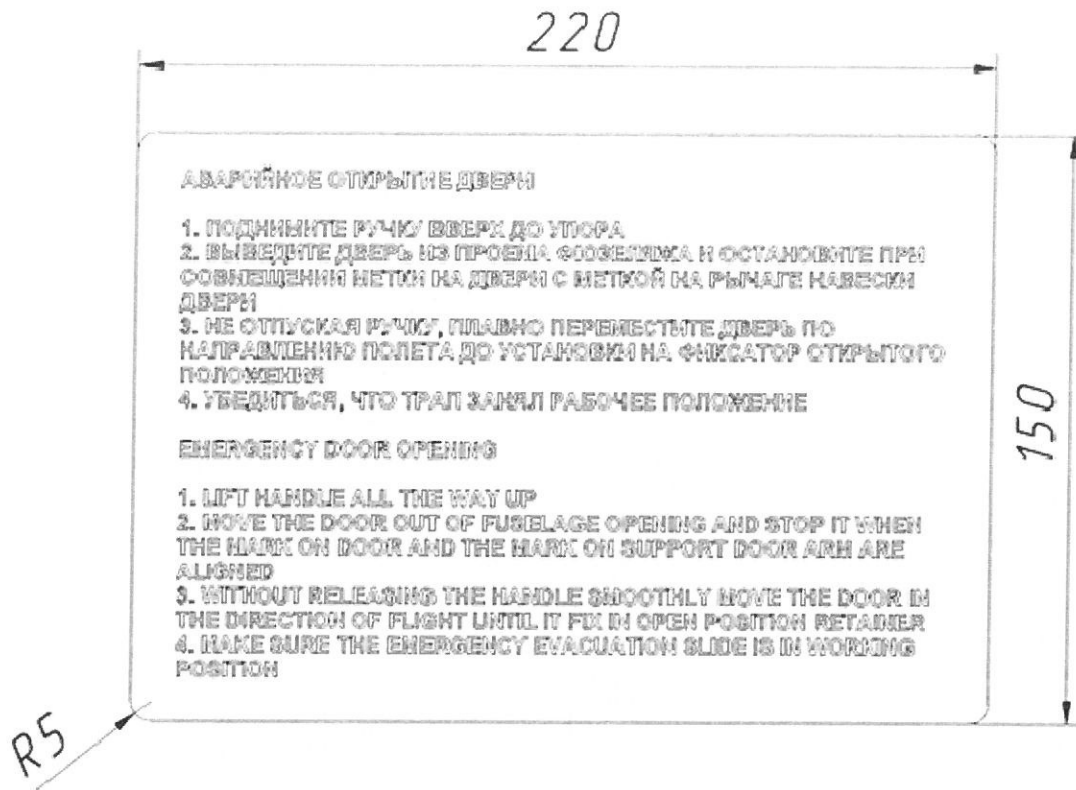
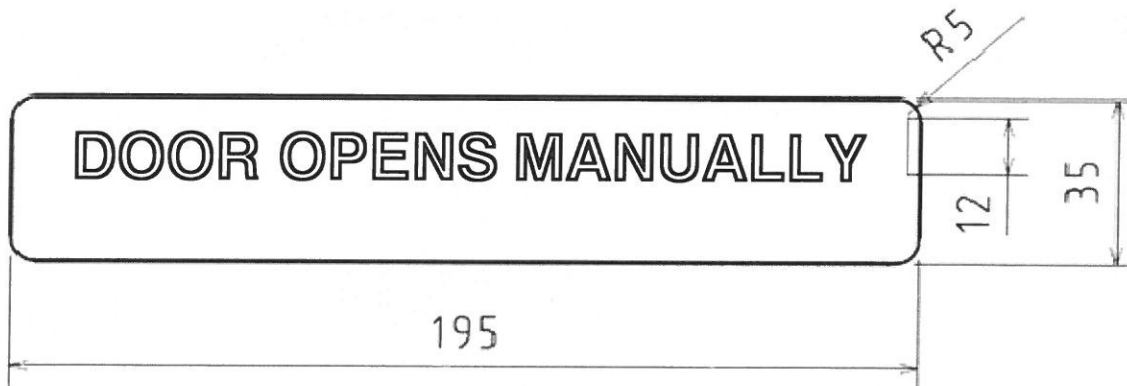
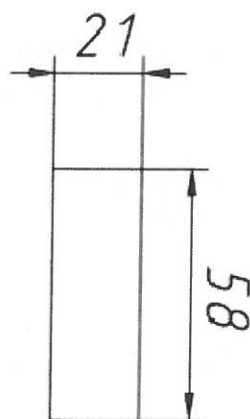
Fig. 4 Placards

The installation of the placard p/n T7.7513.199.002 «DOOR OPENS MANUALLY» is mandatory requirement of Airworthiness Directive №2020-FATA-01020A-04.
